JOB LAWRENCE HISTORY MUSEUM  
 SHEET NO. SKS-5 OF \_\_\_\_\_  
 CALCULATED BY GHM DATE 4.23.06  
 CHECKED BY \_\_\_\_\_ DATE \_\_\_\_\_  
 SCALE \_\_\_\_\_

JOB LAWRENCE HISTORY MUSEUM  
 SHEET NO. SKS-7 OF \_\_\_\_\_  
 CALCULATED BY EHM DATE 2.18.09  
 CHECKED BY \_\_\_\_\_ DATE \_\_\_\_\_  
 SCALE \_\_\_\_\_

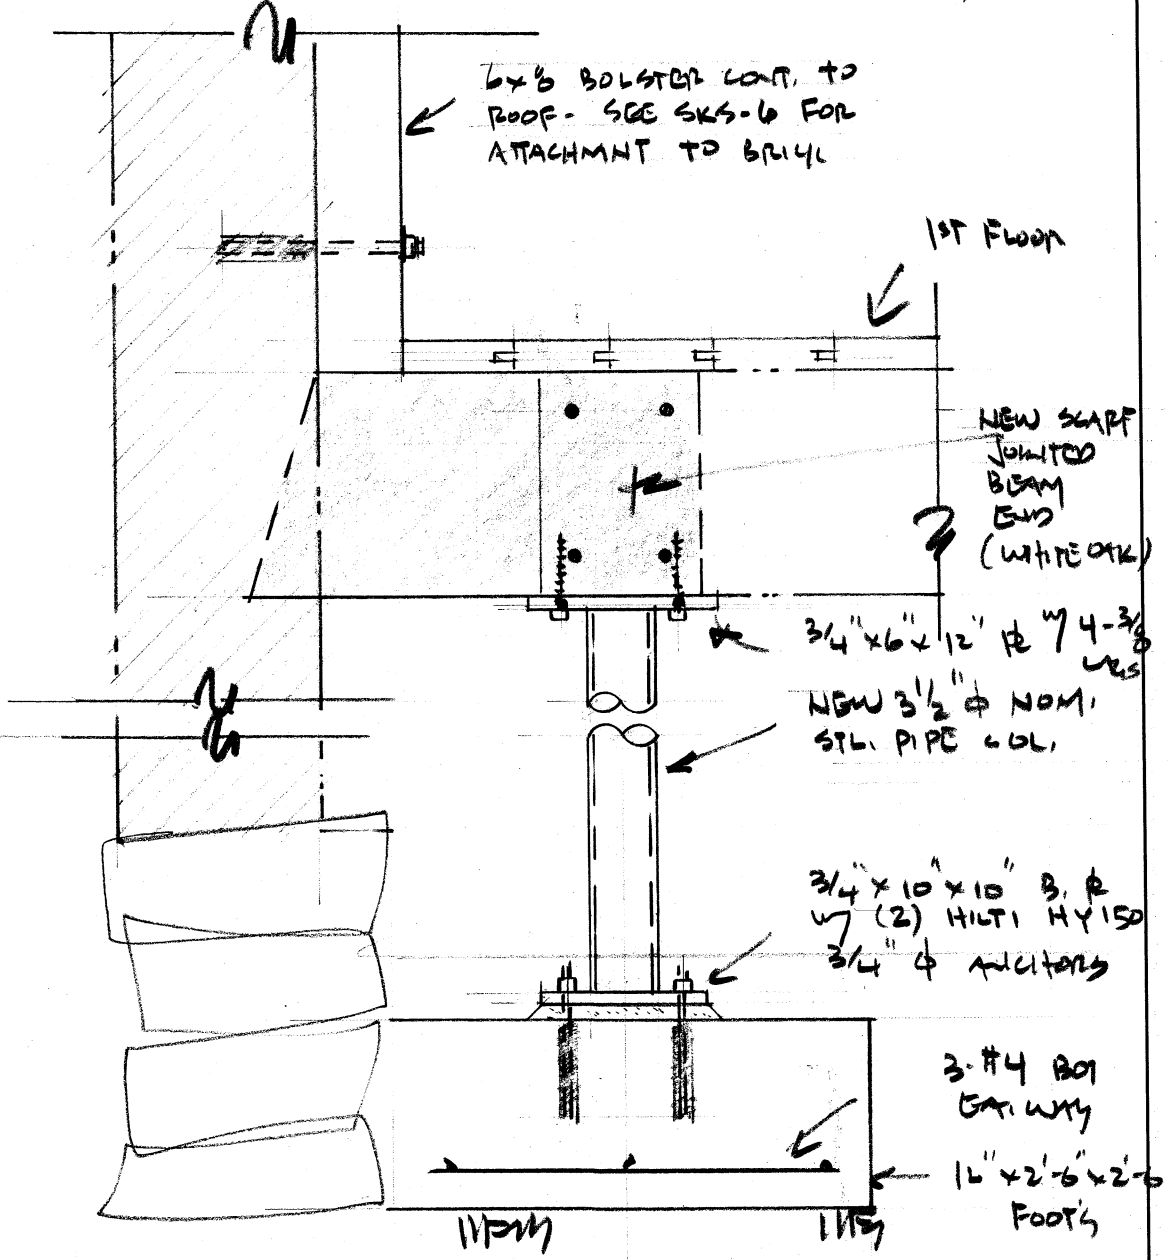
CUT ON 5 SECTION  
 SKS-12 1" = 1'-0"

NOTE: PROVIDE TEMPORARY  
 STOPPING UNTIL BEAM IS  
 REPAIRED & RESUPPORTED

PROVIDE BORACARE IMPEL RODS,  
 1/4" DIAMETER, 8 PER END OF EACH  
 BEAM EMBEDDED IN MASONRY  
 ALONG EAST WALL AT ROOF.  
 INSTALL PER MANUFACTURER'S  
 INSTRUCTIONS.

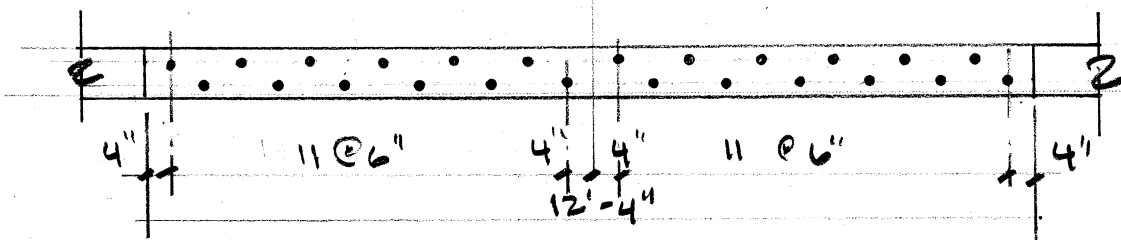
**PLAN OF UNDERSIDE OF BEAM**

← BEAM CRACK
